New Glass - Old Panels

by Dennis Wolter

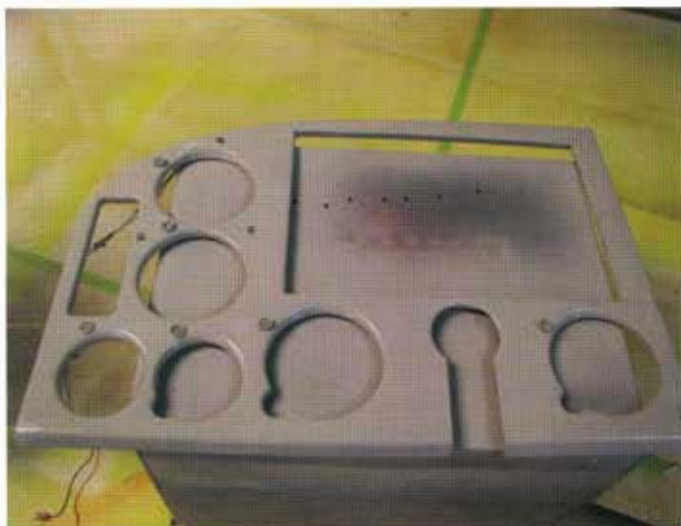
The panel overlay is sanded, filled, primed and ready for paint.

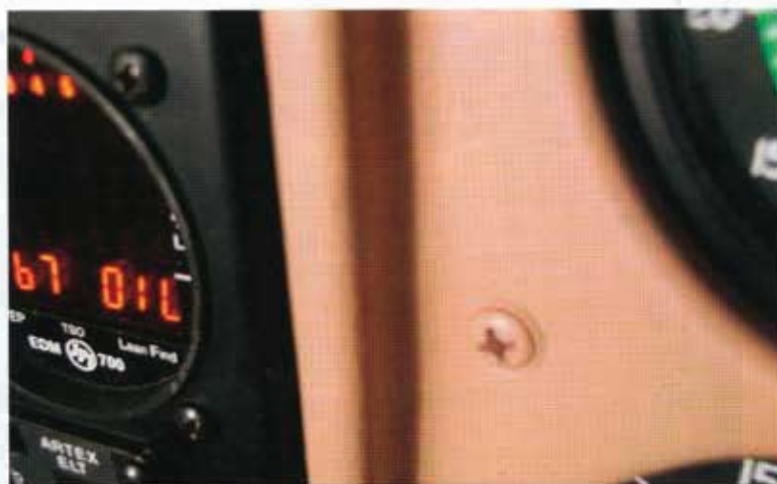
Painted finish screw and washer. Looks good, holds firmly and is easy to install and remove – wow!

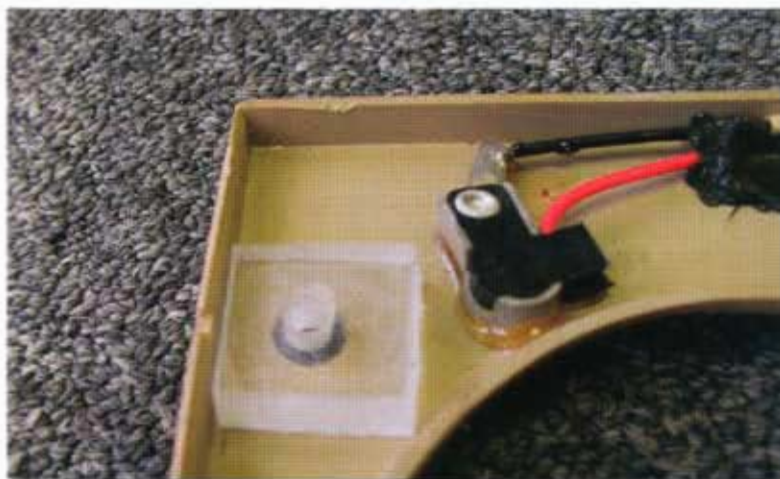
1/4" acrylic mounting screw doubler bonded to the back side of the panel overlay.

No plastic panel overlay discussion would be complete without getting into mounting issues. Except for perhaps the use of bubble gum, Cessna has tried every way imaginable to secure these panel overlays. For over thirty-five years we’ve tried and tried to improve on every one of Cessna’s previous systems. The real fix is to remove the original mounting hardware and install an 8-32 riv nut in the metal subpanel. Then locate a 5/32" hole in the panel overlay on the center of the riv nut, and bond a 1/4" thick 1/2" x 1/2" acrylic spacer over the hole on the back side of the overlay. Go to the front side of the overlay and drill a 5/32" hole through the 1/4" thick spacer. Finally, carefully countersink the finished side of the overlay to accommodate a #8-32 Auveco finish screw and #8 Auveco flush upholstery finish washer. You now have a fool-proof, secure and aesthetically pleasing mounting system for the former flimsily mounted panel overlays. Don’t be shy about adding some additional mounting screws where needed; we do it all the time.

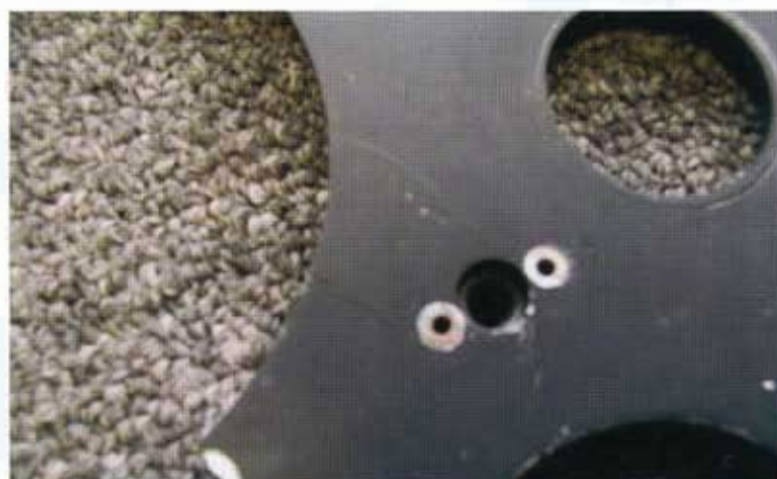
An 8-32 nutplate installed in an oversized hole.

tic pin that mated to a rubber grommet and hole in the metal instrument mounting panel. This hole for the grommet is too large for an 8-32 rivnut, making it necessary to install an 8-32 nut plate on the back side of the instrument mounting panel centered on the original oversized hole. This takes a little more time, but is definitely worth the effort.

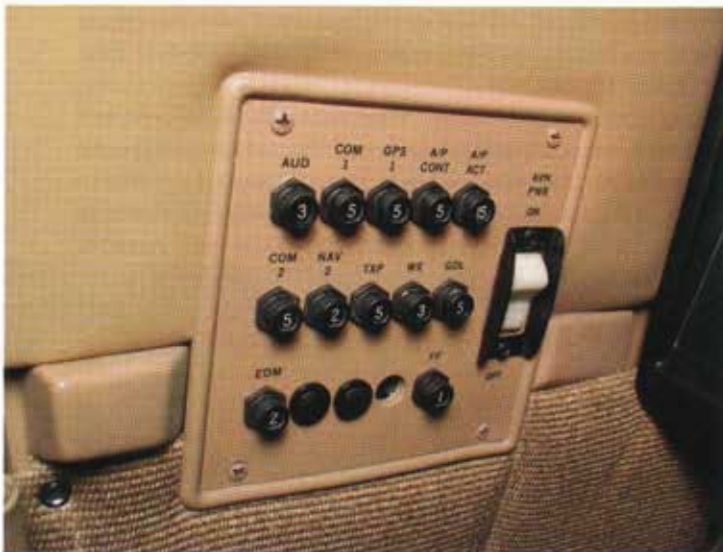
Renovated side panel circuit breaker panel.

The pedestal and side panel circuit breaker panel are removed, repaired, painted and placarded using the same methods as used on the instrument panel overlays and sub-panel components housing controls and circuit breakers.

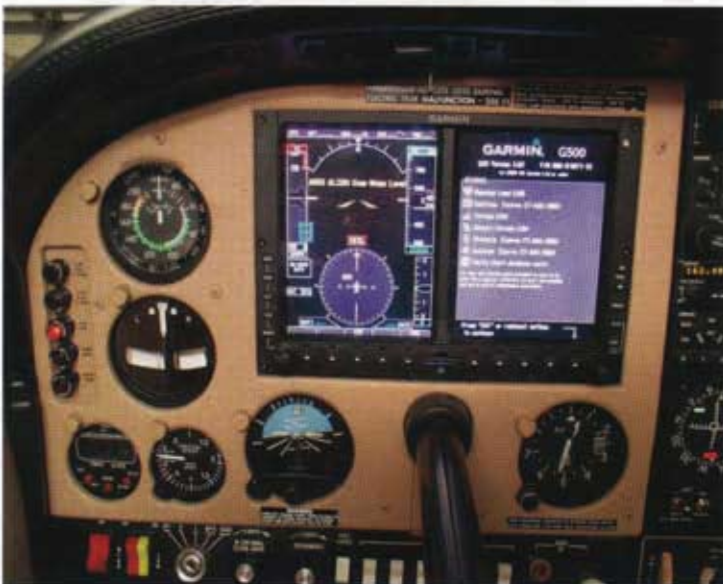
Close-up of the renovated panel with the Garmin 500 installed.
